## Images and comments of the sewage pollution in the Blougat Spruit on the 2<sup>nd</sup> June 2023

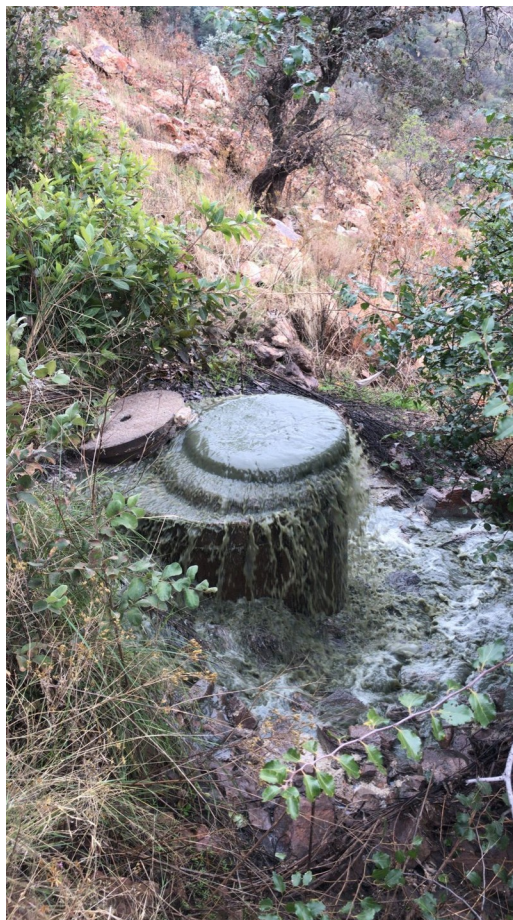
**Red B on the satellite image.**

On the 16<sup>th</sup> May 2023 a member of the community identified raw sewage running down the side of the ravine into the Blougat Spruit. Red B on the satellite image.

On Tuesday the 23<sup>rd</sup> May 2023 we were able to identify a specific manhole on the main sewer line going to Percy Stewart that was overflowing, with a pin drop added. Whilst standing there the colour of the outflow would change from greenish to black and back to greenish. It isn't possible to describe the stench that was present there.

These details were sent to the Mogale Whatsapp complaint number. There was a response that the complaint had been passed to the water department.

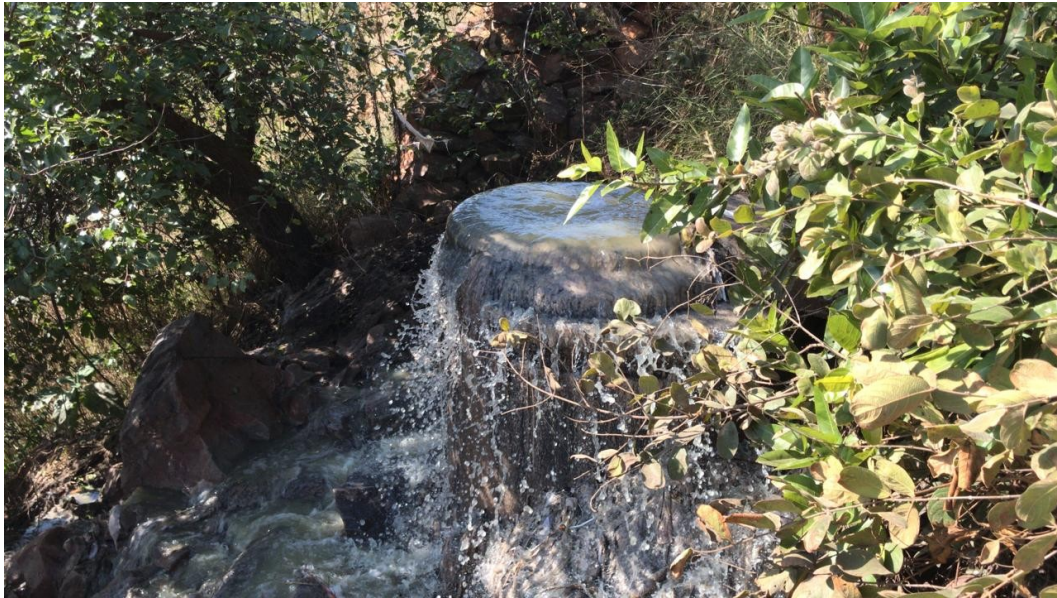
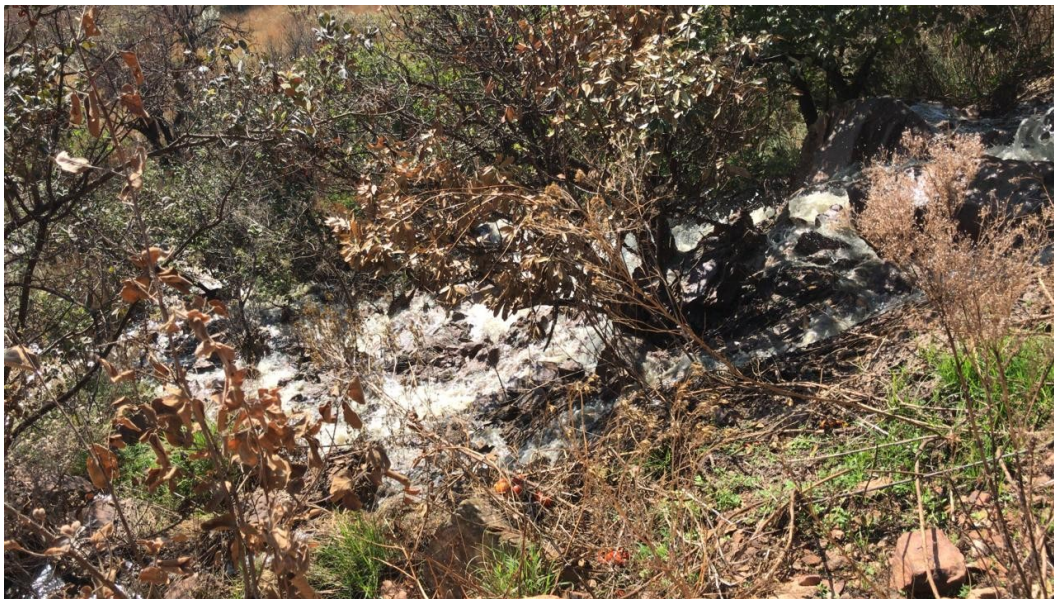
On Friday the 26<sup>th</sup> May 2023 a follow up was done to find the same manhole still overflowing, and flowing down the side of the ravine. No indication of anybody even having attempting to correct the problem. These details were again sent to the Mogale Whatsapp complaint number, this time there was a response with a reference number MCLM Ref: 72794.

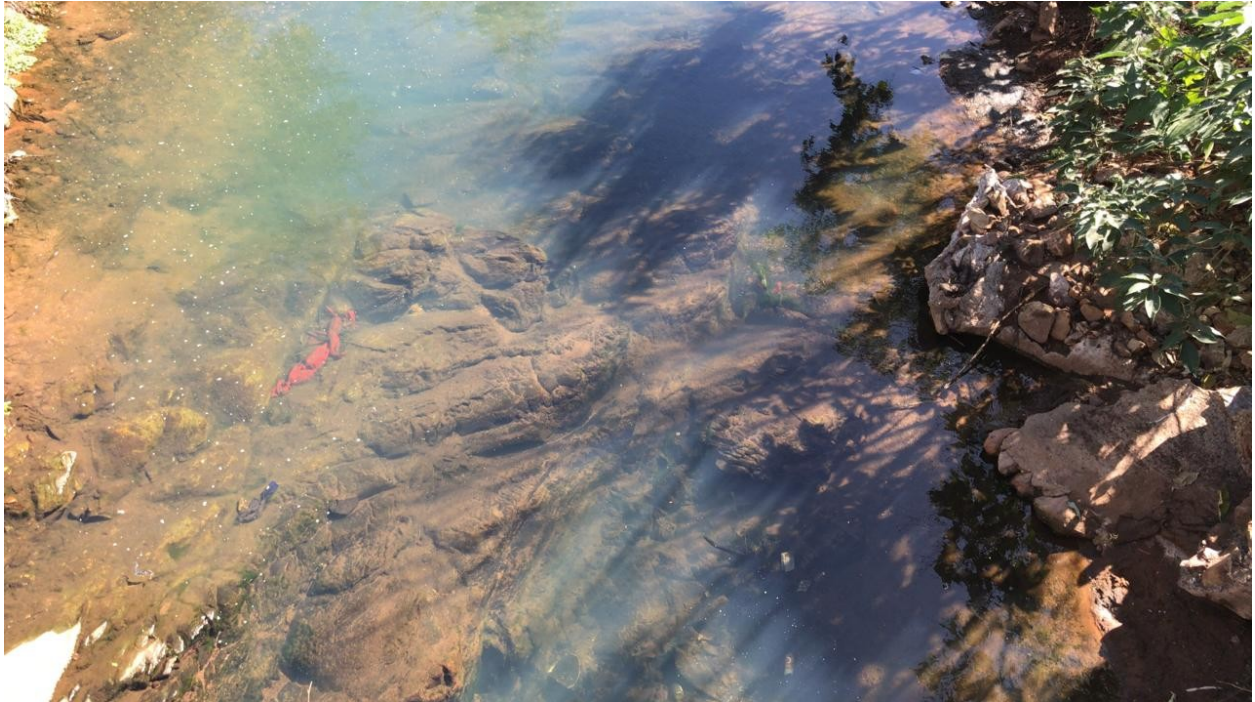
**Red A on the satellite image.**

I started upstream from Percy Stewart close to Robert Broom and observed that the water in the Blougat Spruit was quite clear (a little discolouration present) and was easy to see the river bed and rubbish on the river bed as per the following photo with pin drop. This was taken from a bridge crossing the Blougat Spruit at 12h24.

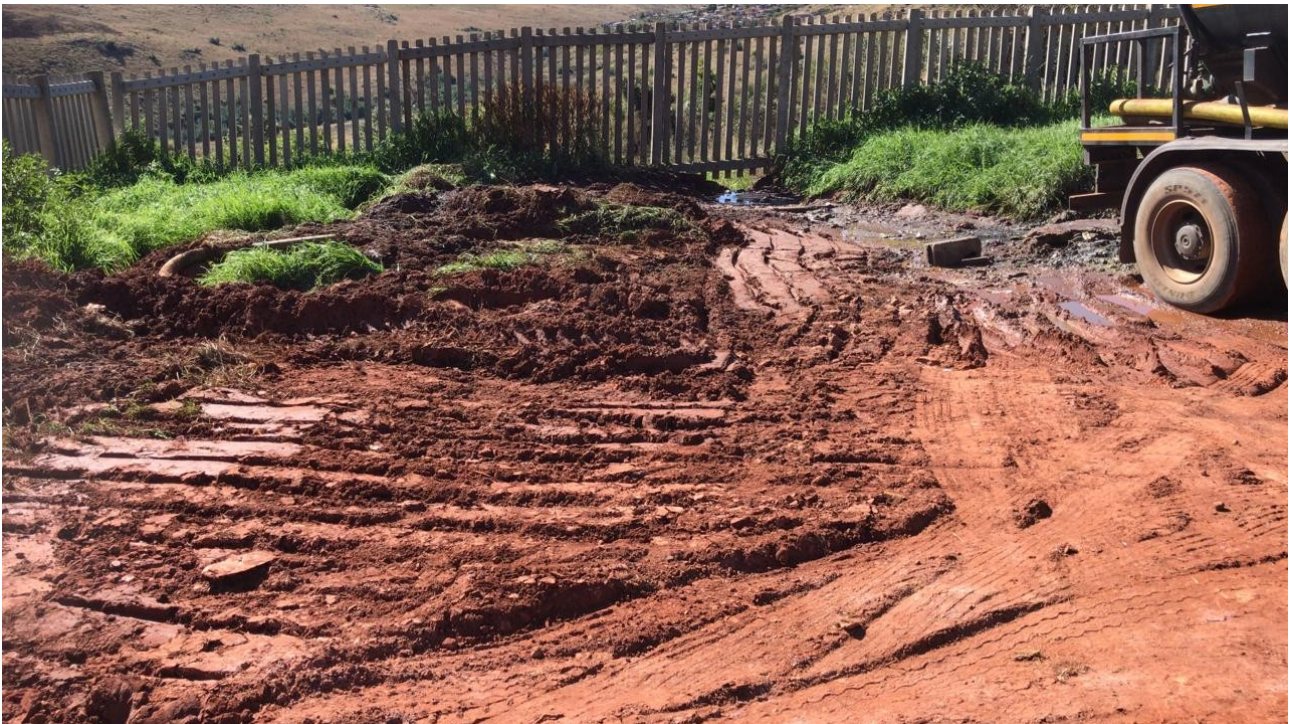
Red B on the satellite image.

The next stop was the location in Delpontan where the sewage trucks empty their loads into a manhole which carries the waste into the main sewer line to Percy Stewart. This site has been problematic since it was started a number of years ago as the construction work has never been completed which results in any overflow or splatter from the trucks ending up flowing down the ravine into the Blougat. From my information at other similar sites there is a better designed funnel arrangement with a barrier wall so that all the waste goes into the sewer line.

What I noticed today is that Mogale seems to have scraped a trench at the back of the manhole to the perimeter fence so that the waste can more easily flow away from where it should be and out to the ravine and the Blougat.

One can see the mess from behind the truck busy emptying into the manhole. From the markings on the ground it can be seen that this was done very recently. Possibly earlier today.

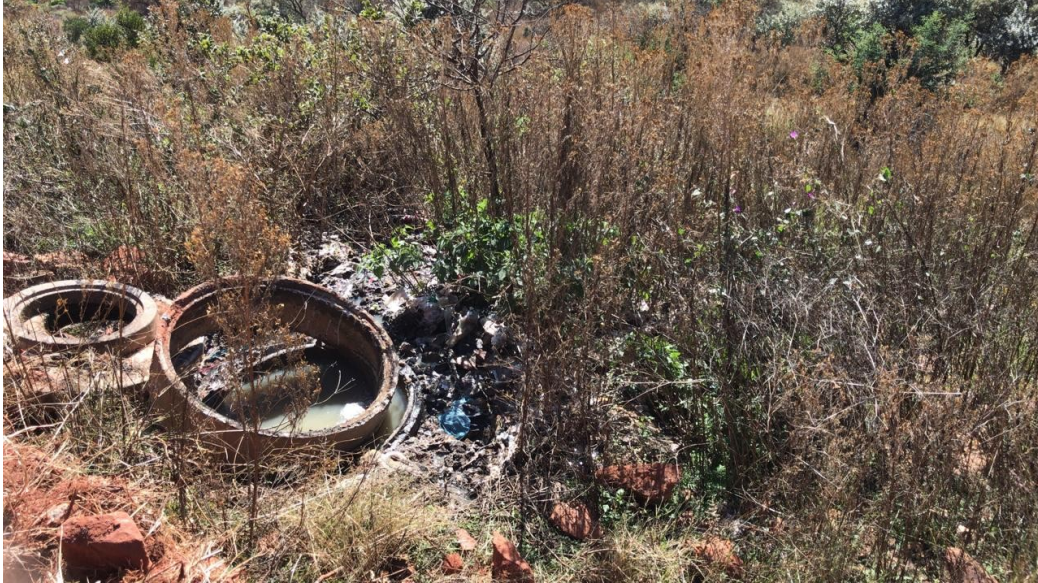
Going to the entrance to the unloading area and looking in the direction of Percy Stewart there is a newly scraped road done to get to the main sewer line as well as some trucks and a TLB. Following the new road past the trucks I came across a manhole partially dismantled and sewage flowing down the side of the ravine.

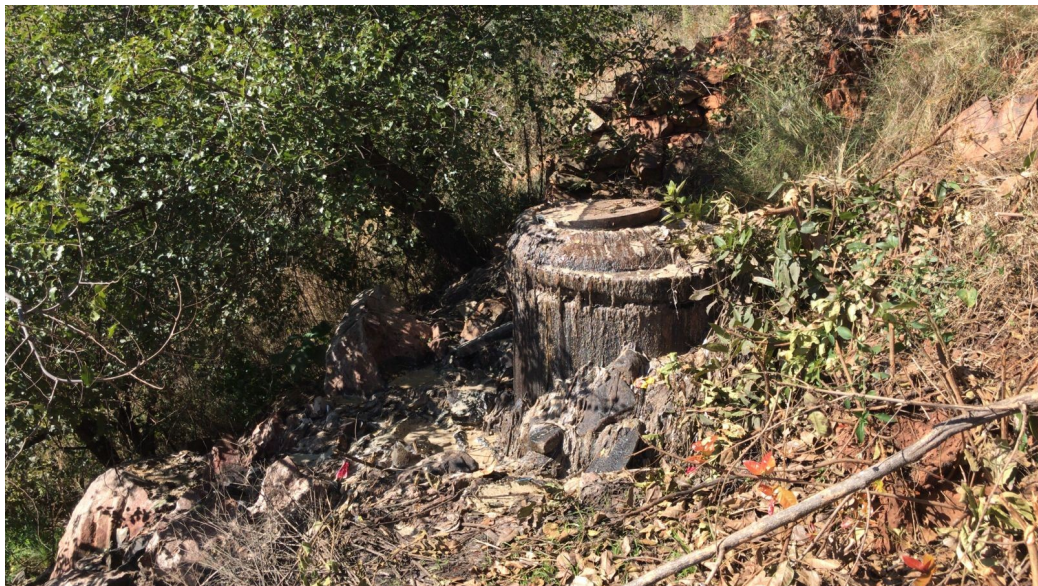
Carrying on along the line I came to the manhole originally identified as overflowing, which although not currently overflowing was very wet around it and seemed to have been overflowing shortly before my check.

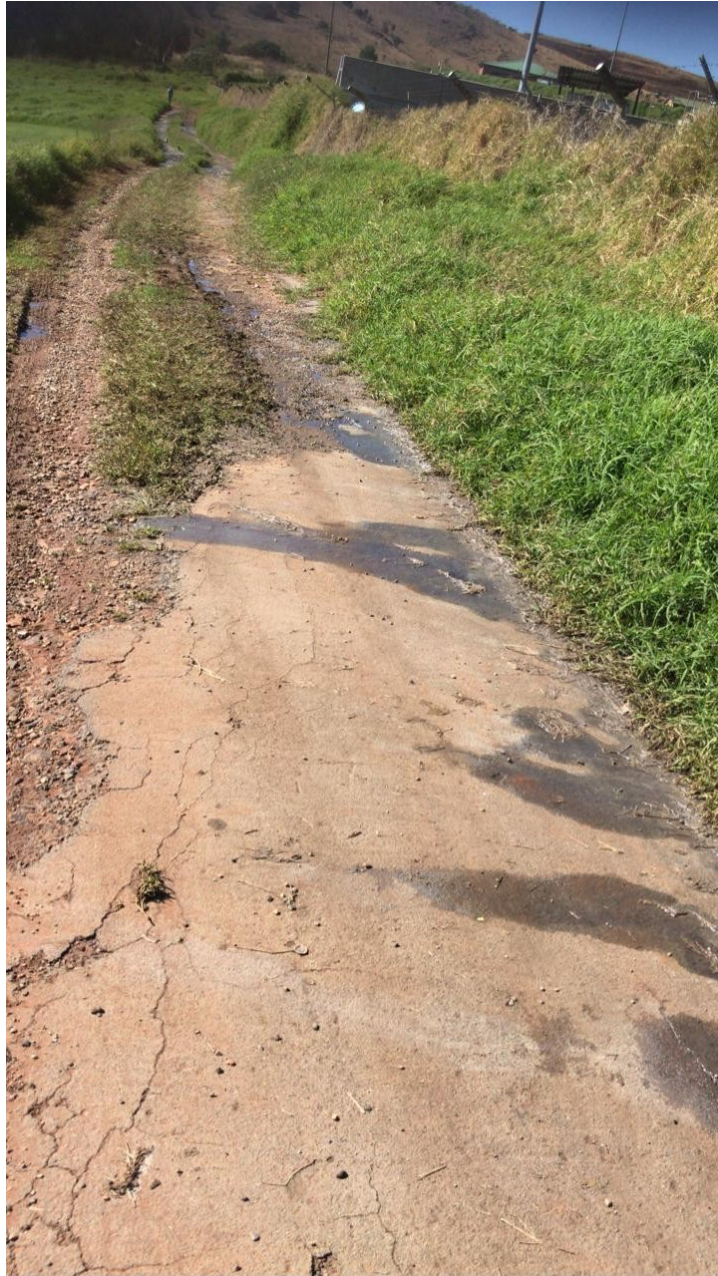
Red C on the satellite image.

Moving I went Past Percy Stewart where none of the rotating arms are rotating, and on to the north west perimeter fence. There is waste trickling out from Percy Stewart onto the perimeter road. Percy Stewart is on the right hand side of the photo.

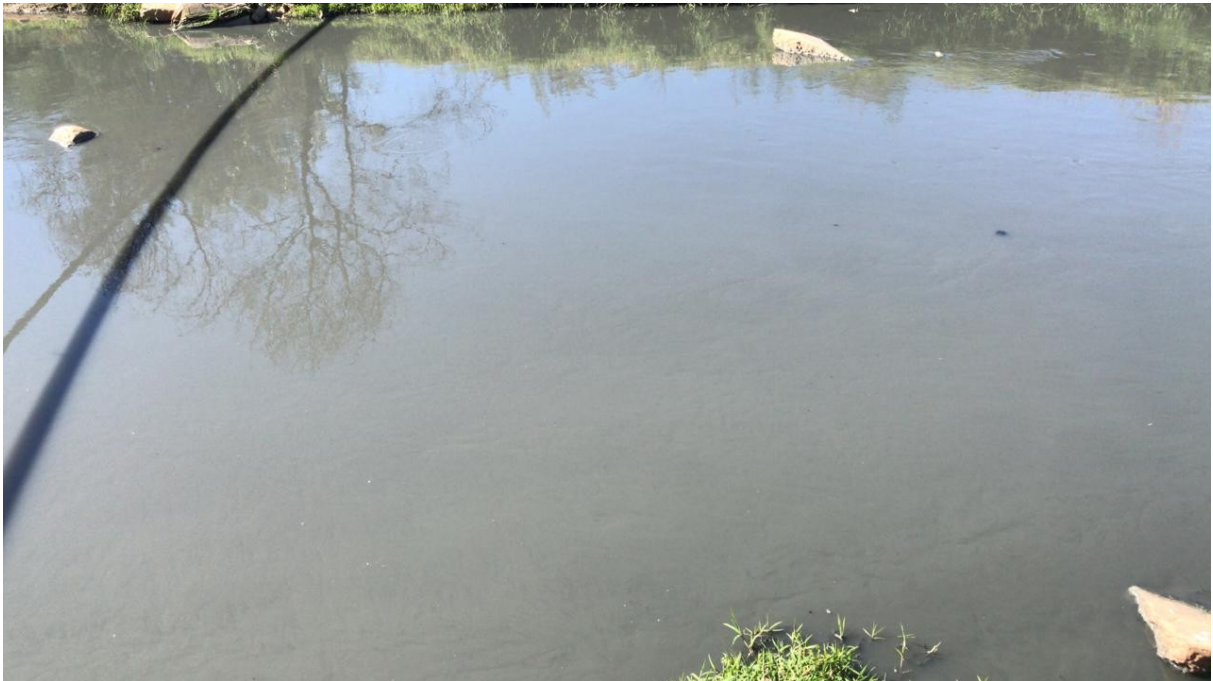
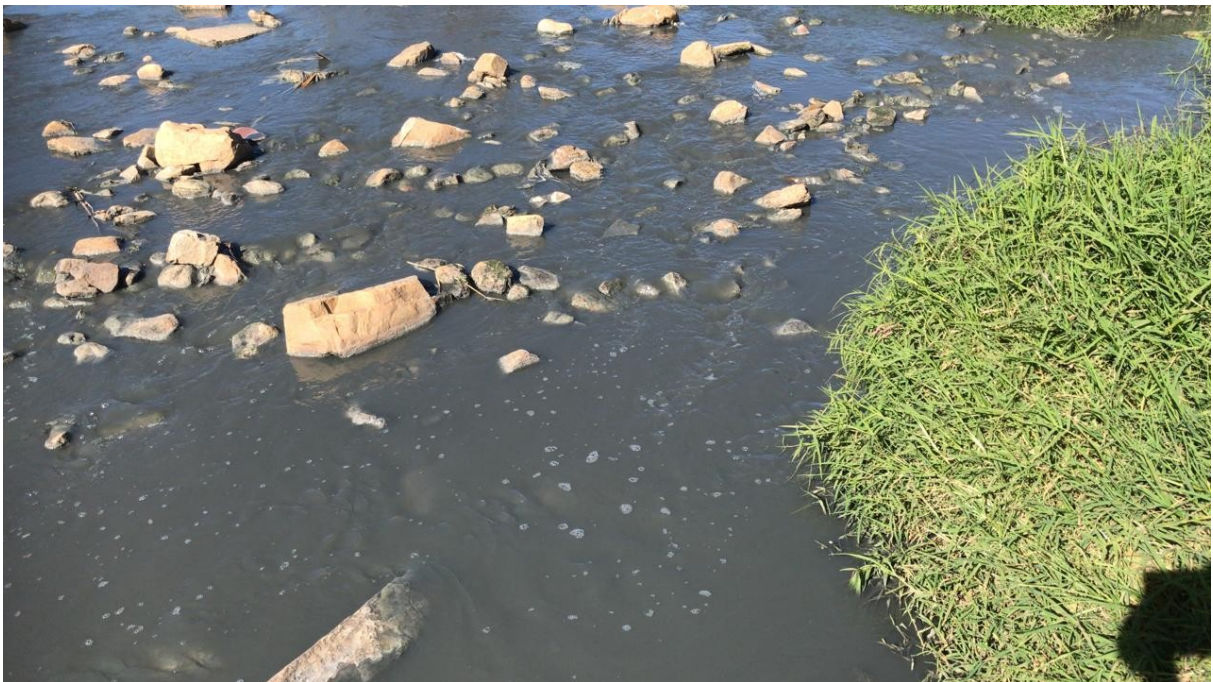
Red D on the satellite image.

Moving on downstream to a point I regularly use one can see the extreme discolouration of the water in the Blougat. At this point there is a stench close to the river that I can best describe as that of a rotten fish market. At this point the visibility is so poor that the rocks above the water are completely hidden below the surface. Today not much foam present.

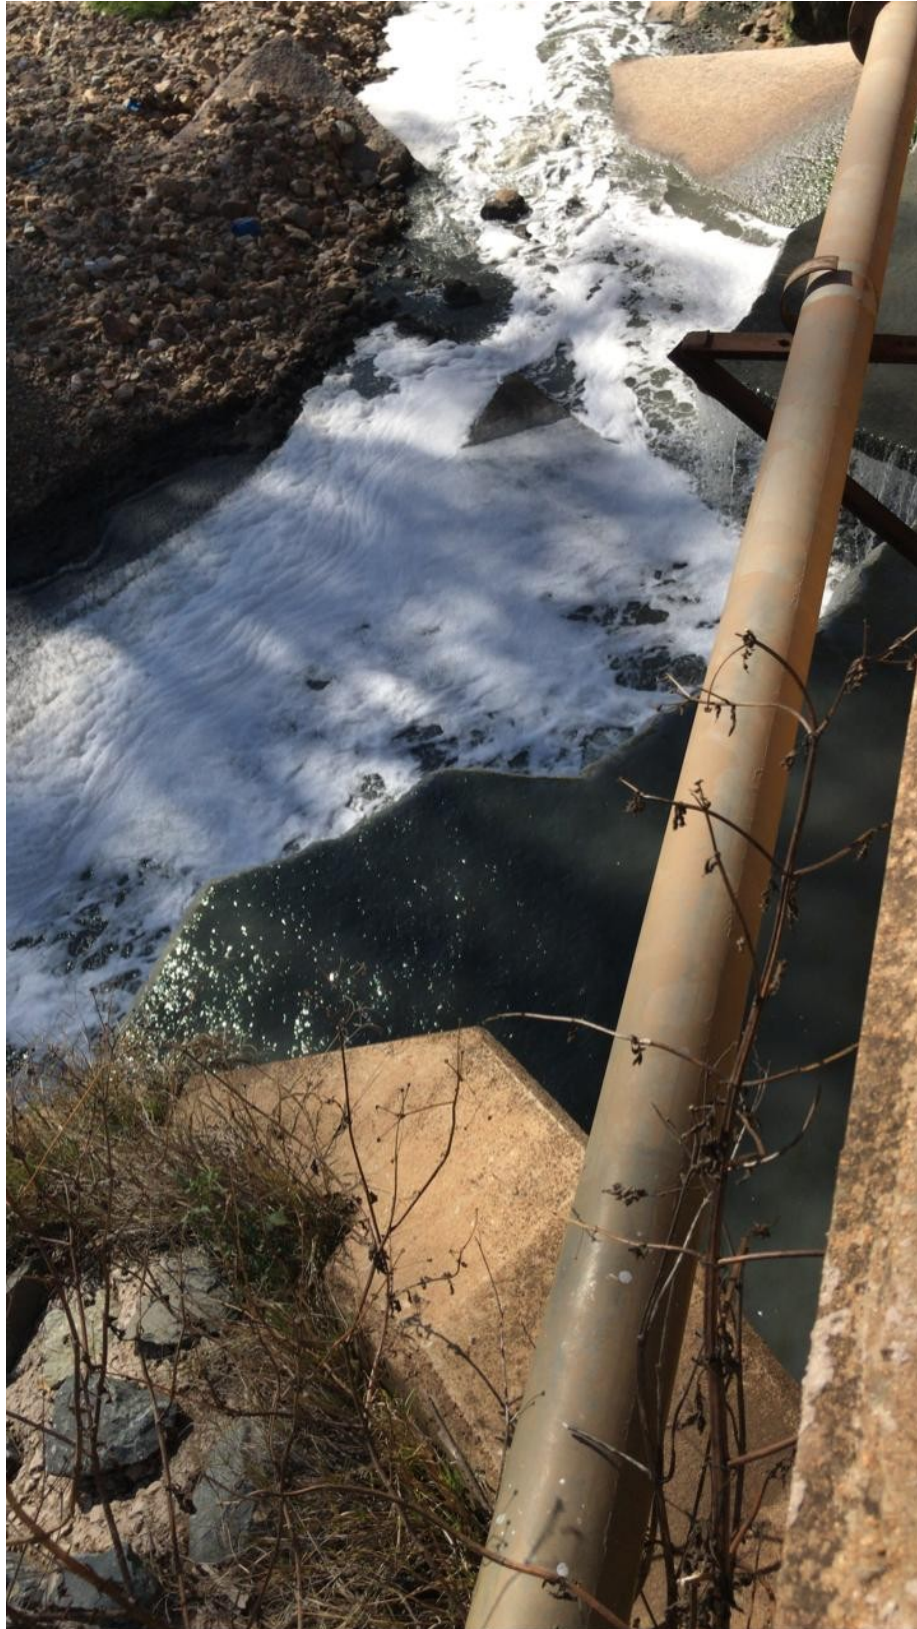
Red E on the satellite image.

My last stop was at the point where the Blougat goes under the N14. At this point there is quite a lot of foam, some of which has a grey discolouration (bottom left of photo). And from here onwards into the Cradle Of Humankind, past restaurants and various tourist facilities.
